Medium Voltage Cable Defects Revealed by Off-Line Partial Discharge Testing at Power Frequency

M. S. Mashikian and A. Szatkowski

IMCORP

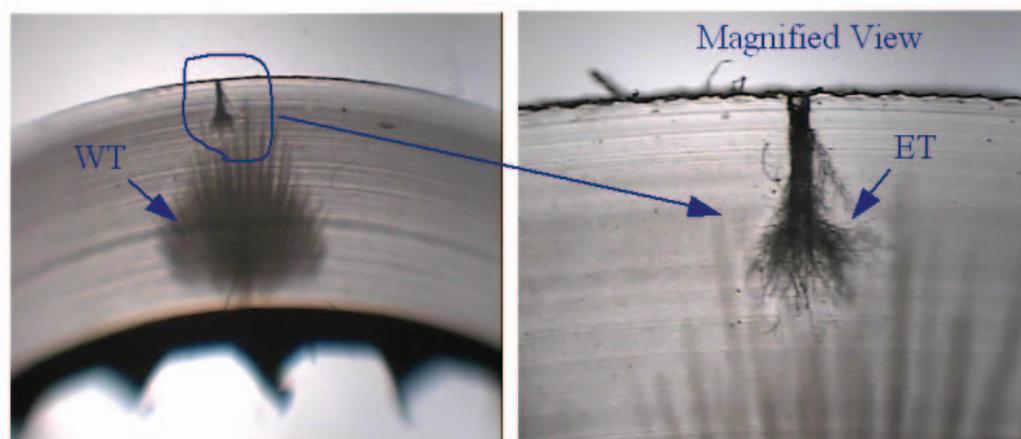
Electrical Tree Growing from Screen toward Vented WT: Figure 5 illustrates a large, vented WT emanating from a conductor screen and an ET emanating from the insulation screen. The ET is growing radially toward the top of the WT. This site was first detected in the field in 2002. The PDIV remained constant at 2.5 p.u. for two additional years in service without failure.

Figure 5. Vented water tree (WT) and electrical tree (ET) growing into each other from opposite screens.

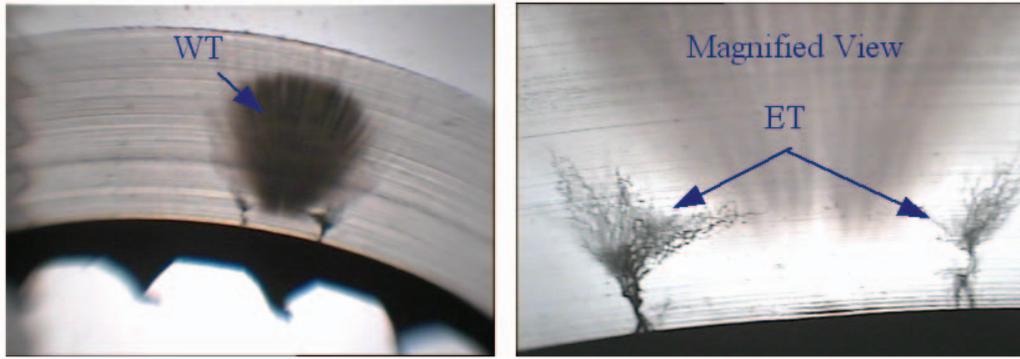
Electrical Tree Emanating from Conductor Screen under a WT: Figure 6 illustrates the case of several ETs emanating from the same screen (conductor screen) and growing in the “shadow” of a large, vented WT. Note that each ET in Figures 5 and 6 is

Figure 6. Vented water tree (WT) and electrical trees (ET) with deflected branches emanating from the conductor screen.

growing in a dry portion of the insulation in which the electric field is enhanced. In Figure 6, the ET branches growing into the WT are clearly deflected laterally (presumably because of a low radial electric field component), and the branches outside the WT are growing radially toward the insulation screen. This PD site was tracked in the field for 3 consecutive years. Its PDIV remained at the 2.0 p.u. level. Although Figure 6 indicates a dry region close to the screen, there may have been a thin, wet trunk that does not show in the cross section.

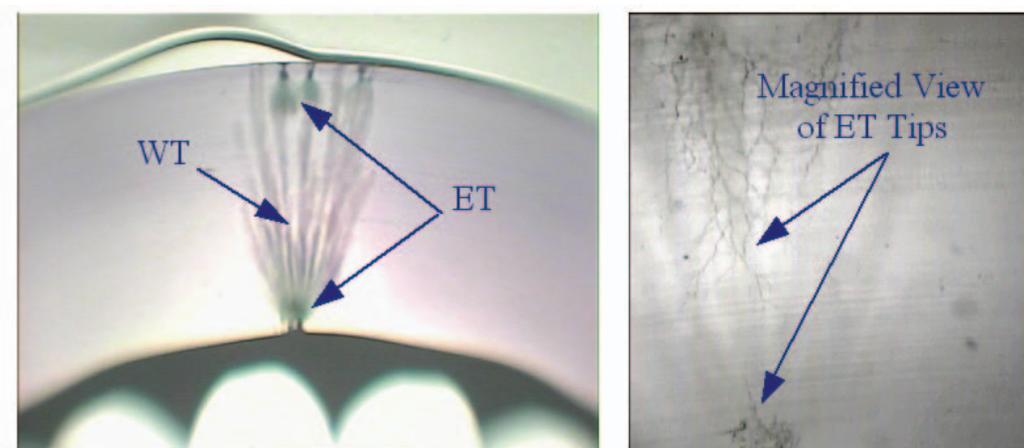
Electrical Tree Emanating from Screens on Both Sides of a WT: Figure 7 illustrates the case of a long, vented WT emanating from the conductor screen of a 15 kV XLPE cable with poor service performance. This unjacketed cable had been in service over 25 years. A PD was detected at 2.5 p.u. test voltage (the initial PDIV was somewhere between 2.0 and 2.5 p.u., the two consecutive levels at which PD was measured). The cable owner requested that a withstand test at 60 Hz be performed at this voltage for 5 minutes, immediately following the PD test. The cable survived this test, but its PDIV dropped to 1.5 p.u., presumably as a result of the further damage caused by the discharge in the insulation during the prolonged withstand test. A cable section containing the PD site was cut off and subjected to a laboratory investigation. The vented WT covered the entire

insulation wall thickness and ETs were observed emanating from the screens on both sides of the WT. The magnified view shows that the tree branches were just about to meet when the withstand test was interrupted. This pattern also has been observed in the presence of bowtie WTs [9].

Figure 7. Electrical trees (ET), with tips close to meeting, on both sides of a long vented water tree (WT).

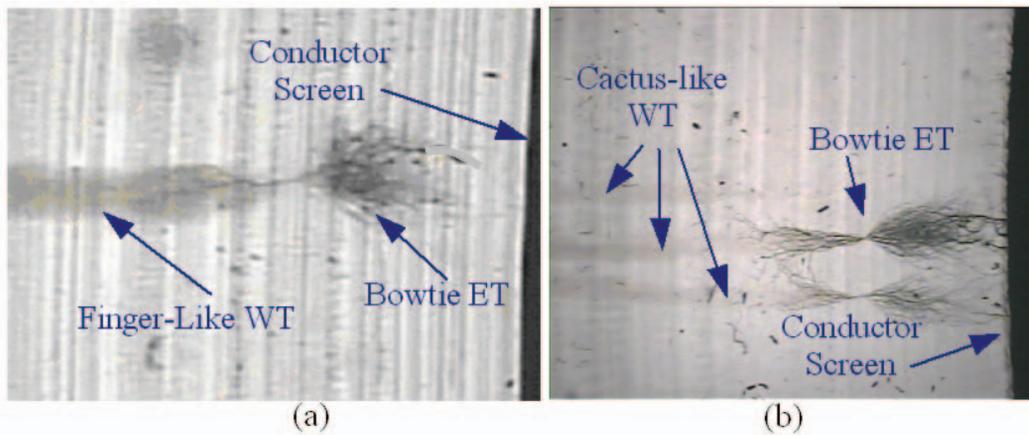
Electrical Trees Growing from Tip of a Finger-Like WT: Figure 8(a) shows a bowtie ET growing at the tip of a long, finger-like WT. This PD site was first noted in the field in 2001. It was reconfirmed in 2002 and 2003. The PDIV remained practically constant at 1.7 p.u. Figure 8(b) is another PD site in the same feeder cable. Again, bowtie ETs are growing at the tips of thin cactus-like WT branches. This PD site was first detected in 2002 and reconfirmed in 2003. The PDIV remained constant at 2.0 p.u.. The feeder was tested in the laboratory and dissected in 2004-2005. The phase resolved diagram for one cycle at 2.5 p.u. voltage for the specimen in Figure 8(a) is shown in Figure 9. It is compatible with that expected for such an ET.

Figure 8. Micrographs of bowtie electrical trees (ET) growing at the tips of finger-like water trees (WT).

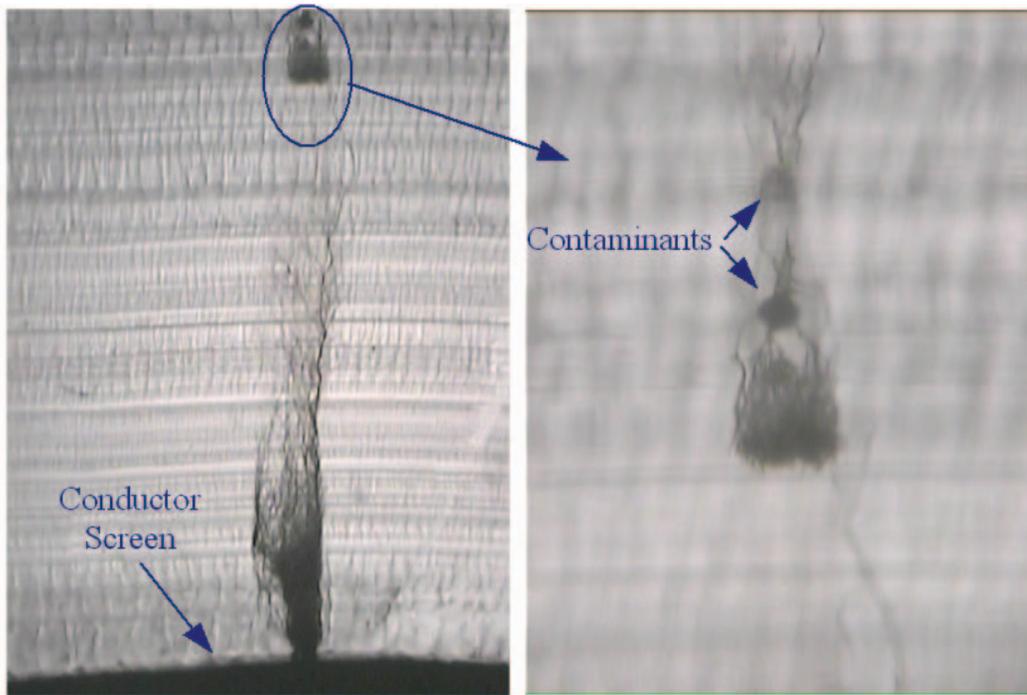
Solid contaminants embedded in the insulation sometimes have been found to be the sites of PD activity. No attempt was made to find the origin of the contaminants by analysis. Figure 10 is such an example. This site was first discovered in the field

at 2.5 p.u. voltage in 2002 and was reconfirmed in 2003.

Laboratory testing and dissection were performed in 2004-2005. Electrical trees are seen linking two contaminants, and another elongated ET is seen emanating from the conductor screen, probably at the site of some surface roughness. A phase resolved PD diagram (PD magnitude versus phase angle at which PD occurred during one cycle of the applied voltage) obtained at 2.5 p.u. voltage is shown in Figure 11.

Figure 10. Electrical trees (ET) are linking two contaminants and another ET is emanating from the conductor screen.

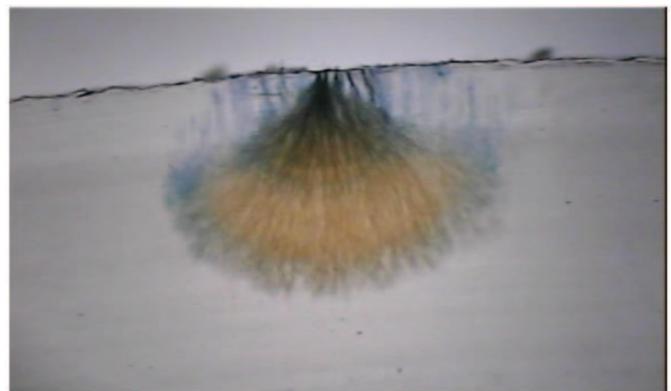
The bush-type tree has been observed repeatedly on 1000 kcmil (~500 mm²) Al-conductor, 15 kV XLPE insulated feeders with copper concentric neutral and a jacket. No visual evidence of water treeing exists. Figure 12 provides an overall view of the tree, and Figure 13 is a magnified view of another such tree, showing more clearly the branches of the ET. The trees emanate from the insulation screen. Generally, they consist of a main bush and a large number of “seedlings” growing around its trunk, presumably at the sites of interface stress concentration areas. These trees, reminding one of certain sea shells, have a striking combination of blue, green, and rust colors. The tree tops are evenly rounded, minimizing any leading edge stress concentration. The PD site depicted in Figure 12 was observed at 2.0 p.u. voltage during PD tests conducted 12 months apart while the cable remained in service between tests. In the laboratory, sev-

Figure 12. Bush-type electrical tree (ET) emanating from the insulation screen of 15 kV feeder.

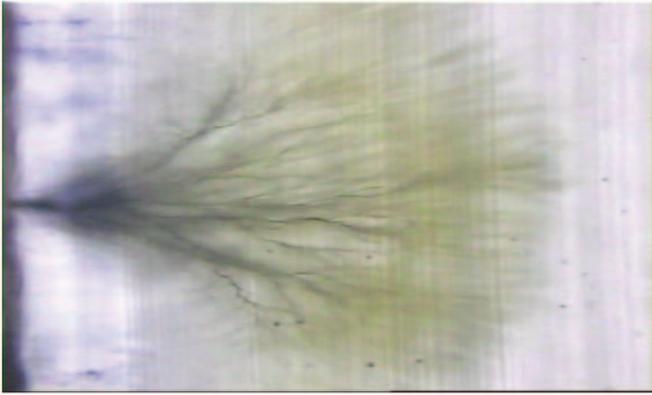
Figure 13. Magnified view of bush-type electrical tree (ET) showing structure of its branches.

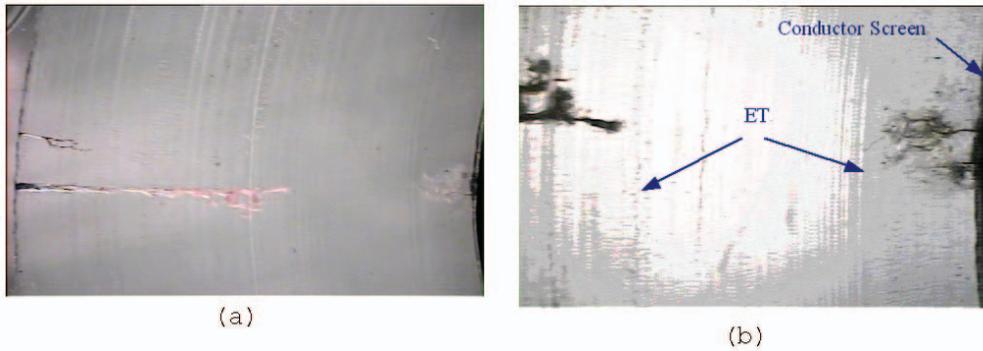
Although a WT can retard the growth of an ET during service, this delay cannot last for ever. Experiments conducted in the field and in the laboratory have shown that withstand tests (with both power frequency and VLF voltage) lasting as long as 30 minutes can significantly decrease the PDIV at a defect site without causing failure. If the PDIV drops to operating level, an imminent failure should be expected. Figure 7 offers a pictorial example of ETs emanating from both screens just about to meet and cause a cable fault.

Figure 15. ETs growing from both screens at the site of an old water tree (WT).

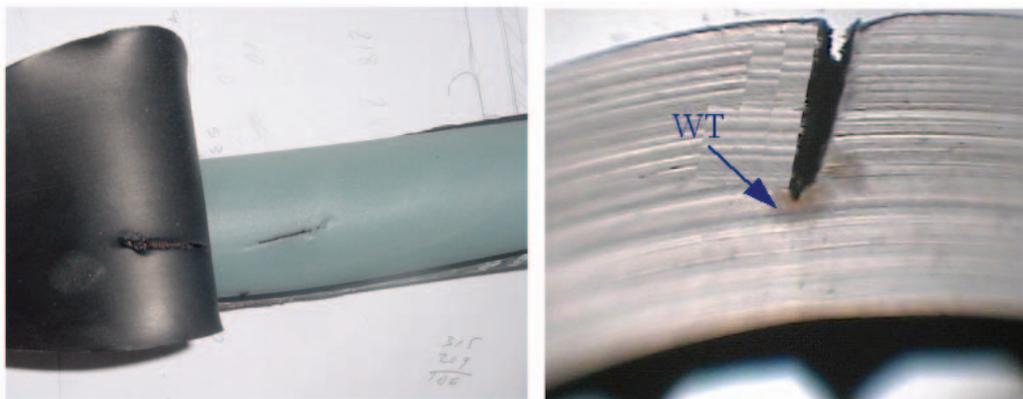
fect encountered, except in cases in which a physical damage was inflicted during transportation or installation (Figure 16), or when, owing to poor factory quality control, delaminated layers of insulation and semiconducting shields went unnoticed. Of all such PD sites identified during field tests, none had lead to the development of ETs.

Figure 16. Deep gash, over 50% of the insulation, made during installation.
