Identifying Oversized Joints with Factory Grade® Technology

Substandard oversized joints identified with IMCORP Factory Grade® Technology

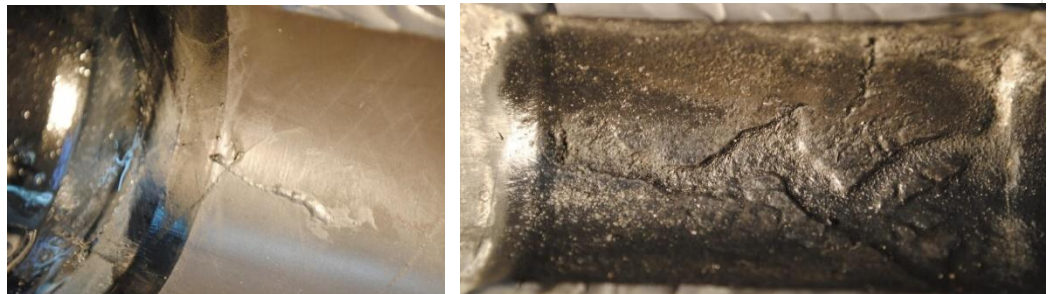
The dissection and root cause analysis produced evidence of electrical (or carbon) treeing between the inside surface of the joint and the cable insulation (the joint interface). Electrical treeing was observed at the same location in both joint samples only treeing is much more extensive in the joint that failed in service. Electrical treeing started near the connector (where the Faraday cage makes contact with the cable insulation) and grew along the interface towards one end of the joint. (Figure 1). Comparisons of the manufacturer's catalogue product size selection table and the cable diameter revealed these were the loosest fitting of three models covering this cable size range. A looser fitting joint increases the likelihood of interfacial voids and other installation errors leading to substandard performance. Voids and stress enhancements in the presence of sufficient voltage stress gives rise to partial discharge, erosion, electrical treeing and eventually failure. Other workmanship issues identified included incorrect dimensions, contamination on the interface, and little to no evidence of void filling grease applied at the cable's semicon cutbacks.

Figure 1: Evidence of electrical treeing was observed on the inside surface of both the serviceable joint with substandard PD activity (left) and the faulted joint (right).

The utility learned the value of a Factory Grade® assessment since the substandard performance was only observable at 1.5 times the operation voltage and would have been completely missed if the assessment was only performed at operating voltage. By partnering with IMCORP our client utility gained critical knowledge about their joint performance and soon made significant changes to their joint specification and retrained their installers.
