Identifying Workmanship Installation Issues at a Solar Site

Solar Site Uses IMCORP Factory Grade® Technology to Achieve Precision Reliability™

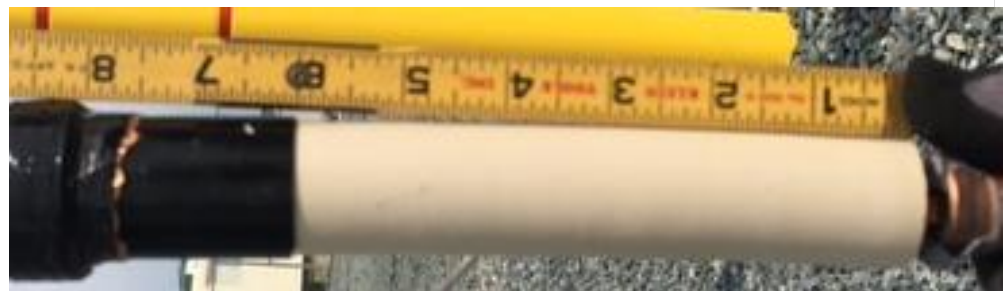
Working with the manufacturer, installation contractor, client utility's engineer, and construction supervisor, IMCORP dis-assembled the substandard terminations in the field and identified several installation issues. The most obvious issue was the incorrect insulation/semicon cutback dimensions (Figure 1). The manufacturer's insulation instructions required the dimensions, from the end of the insulation to the semicon cutback to be 13-inches. All 12 substandard terminations had 6-inch cutbacks. This error caused the termination kit's electrical stress control element and void filling compound to fall well below the semicon cutback. The semicon cutback is the point of highest electrical stress in the termination. Other issues identified included jagged/non-radial semicon cutbacks and cuts into the cable insulation. The terminations were repaired and re-assessed with IMCORP's Factory Grade® technology. This action verified the entire cable system met or exceeded the cable and accessory manufacturers' performance standards.

Figure 1: Field dissection revealing incorrect 6-inch semicon (black layer) cutback.
