CASE STUDY

Identifying Workmanship Issues with Factory Grade® Technology

Contractor Workmanship Feedback with IMCORP Factory Grade® Technology

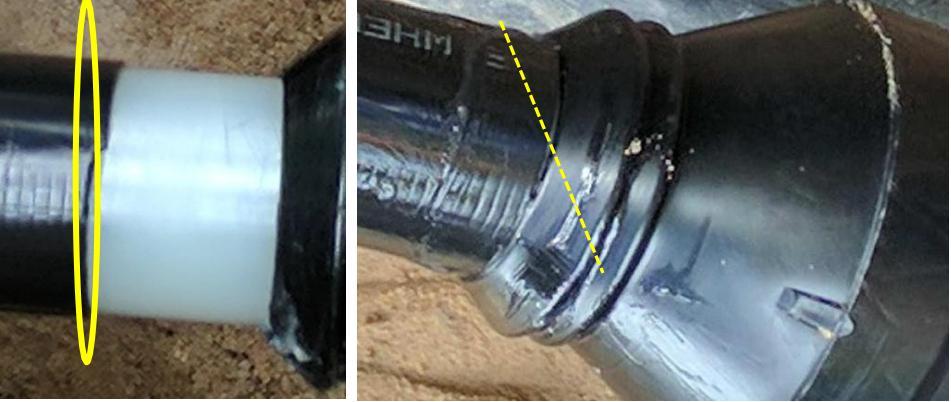
Working with the manufacturer, installation contractor, and the utility client's engineer and construction supervisor, we directed the disassembly of the joints and identified several installation workmanship issues including, insufficient void filling grease, non-radial semicon cutbacks, insufficient connector crimping, improper application of the end caps, and an extreme bending radius near one of the joints. The workmanship issues were corrected and the joints were re-assembled. Our Factory Grade® technology then verified the entire cable system met the manufacturer's performance standards. This case is yet another example of IMCORP partnering with utility clients to ensure quality and educate installers on how to identify defects with immediate evidence-based feedback before failure.

Figure 1: Field disassembly of the premolded joints showed non-radial and jagged cutbacks (left) creating stress-enhancements. Evidence of insufficient void filling grease applied under the end caps on both sides of the joint body (right, yellow circle), creating large air voids between the two mating surfaces.
