CASE STUDY

Commissioning of Underground Transmission Systems

Preventing Service Outages by Identifying Installation Issues with IMCORP Factory Grade® Technology

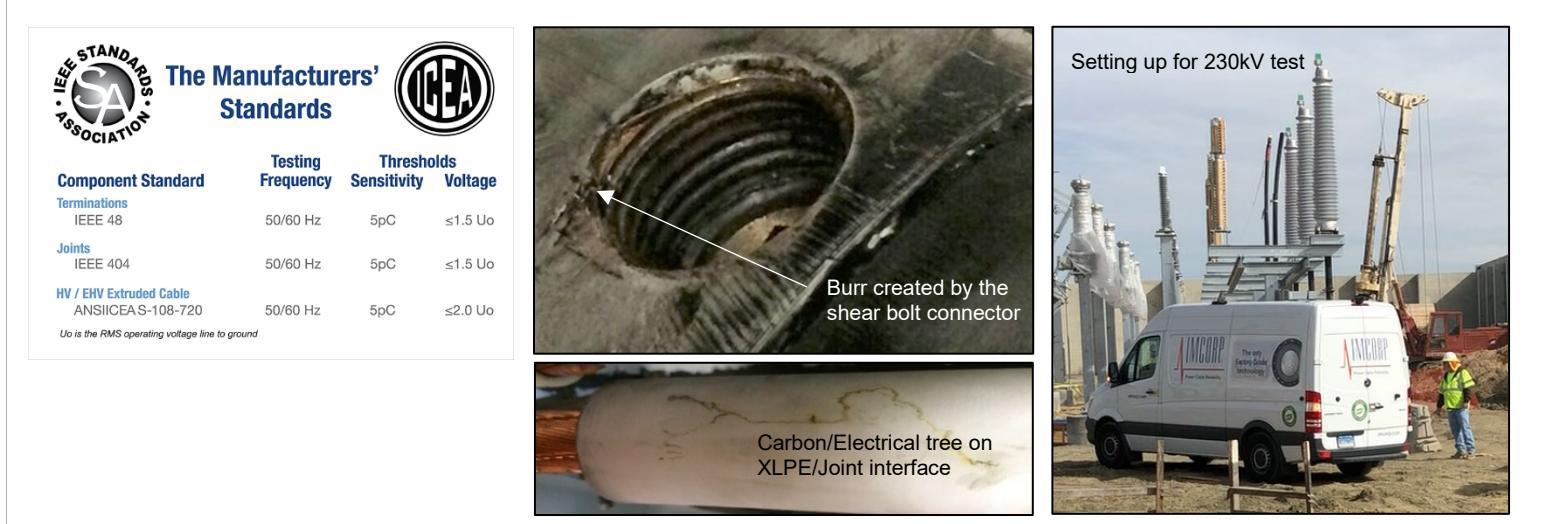
A dissection confirmed the initial test results on the substandard joint. The installation of a shear bolt conductor connector was not properly completed, and a small burr created at one of the threaded holes remained. When the pre-molded joint was slid into place, this burr sliced through the interior surface of the joint, resulting in substandard PD activity, electrical/carbon treeing and subsequent failure. The cable ends at the joint were cleaned, sanded, and the repair joint was installed within 24 hours. The new 230kV cable systems are initially operating in service at the 115kV level and will be for several years until future upgrades are completed. Had this cable only been tested to the 115kV levels (such as during an online test), no issues would have been detected and it mostly likely would have survived in service until energization at the full 230kV level, years after the warranty expired. Ultimately, the IMCORP Factory Grade® test technology saved the client a future outage and enabled immediate root cause investigation and corrective actions for future installations.
