Medium Voltage Cable Defects Revealed by Off-Line Partial Discharge Testing at Power Frequency

M. S. Mashikian and A. Szatkowski

IMCORP

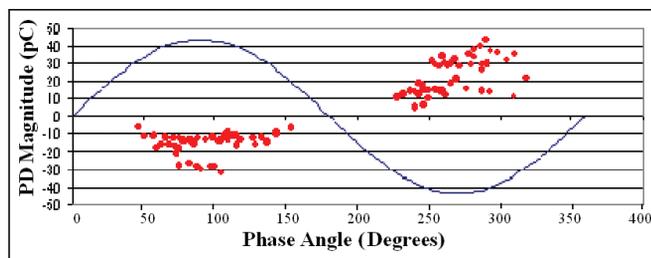
Electrical Trees Growing from Tip of a Finger-Like WT: Figure 8(a) shows a bowtie ET growing at the tip of a long, finger-like WT. This PD site was first noted in the field in 2001. It was reconfirmed in 2002 and 2003. The PDIV remained practically constant at 1.7 p.u. Figure 8(b) is another PD site in the same feeder cable. Again, bowtie ETs are growing at the tips of thin cactus-like WT branches. This PD site was first detected in 2002 and reconfirmed in 2003. The PDIV remained constant at 2.0 p.u.. The feeder was tested in the laboratory and dissected in 2004-2005. The phase resolved diagram for one cycle at 2.5 p.u. voltage for the specimen in Figure 8(a) is shown in Figure 9. It is compatible with that expected for such an ET.

Figure 9. Phase angle diagram obtained at 2.5 p.u. for specimen in Figure 8(a).

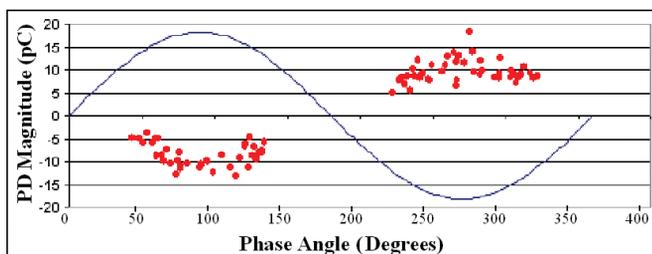
Laboratory testing and dissection were performed in 2004-2005. Electrical trees are seen linking two contaminants, and another elongated ET is seen emanating from the conductor screen, probably at the site of some surface roughness. A phase resolved PD diagram (PD magnitude versus phase angle at which PD occurred during one cycle of the applied voltage) obtained at 2.5 p.u. voltage is shown in Figure 11.

Figure 11. Phase angle diagram obtained at 2.5 p.u. for specimen in Figure 10.

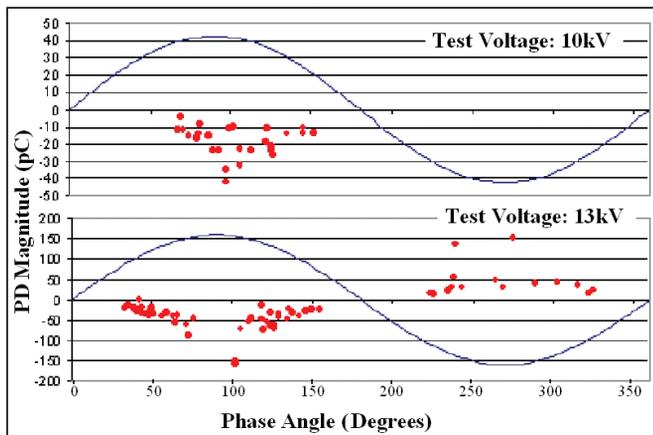
eral months after decommissioning and storing outdoors, the PDIV had dropped to approximately 1.2 p.u.. The different PD phase patterns of Figure 14 for one cycle at 10.0 kV and 13.0 kV are interesting and may shed light on how the PD evolves with increasing voltage.

Figure 14. Phase angle diagram for the defect in Figure 12 at two voltage levels.

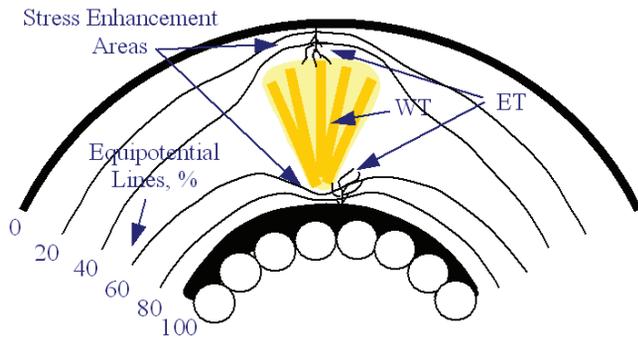
Water trees have significantly higher permittivity and conductivity than the dry portions of insulation. Under 60 Hz or higher frequency electric fields (such as those encountered under switching surge or lightning conditions), voltage distribution within the cable insulation occurs mainly through capacitive coupling and, therefore, is dictated by permittivity. Areas with water treeing have relatively higher capacitance and, therefore, assume a smaller proportion of the total voltage, while the adjacent dry areas of insulation become overstressed. This is depicted in Figure 17 by means of equipotential lines that show two enhanced stress areas around the WT. As the WT grows larger, so does the stress in these areas. Should there be, in addition, any unusual roughness over the surface of the screen or some other inclusion in these areas, an electric tree is generated, especially during transient overvoltage conditions. Electrical trees thus started tend to grow every time the stress exceeds the PD inception level at the tip of the ET. This continues until, relatively rapidly, the ET tip meets the boundary of the WT, which represents a low stress region. At this juncture, the

Figure 17. Stress enhancement areas, sites of possible electrical trees (ET), created by a water tree (WT).
